**DEPARTMENT OF TRANSPORTATION**

Contract #: 04-0120F4Cty: SF/ALA Rte: 80 PM: 13.2/13.9File #: 1x.28**WELDING INSPECTION REPORT****Resident Engineer:** Casey, William**Address:** 333 Burma Road**City:** Oakland, CA 94607**Report No:** WIR-026734**Date Inspected:** 18-Nov-2011**Project Name:** SAS Superstructure**OSM Arrival Time:** 630**Prime Contractor:** American Bridge/Fluor Enterprises, a JV**OSM Departure Time:** 1530**Contractor:** American Bridge/Fluor Enterprises, a JV**Location:** Job Site**CWI Name:** Bernie Docena**CWI Present:** Yes No**Inspected CWI report:** Yes No N/A**Rod Oven in Use:** Yes No N/A**Electrode to specification:** Yes No N/A**Weld Procedures Followed:** Yes No N/A**Qualified Welders:** Yes No N/A**Verified Joint Fit-up:** Yes No N/A**Approved Drawings:** Yes No N/A**Approved WPS:** Yes No N/A**Delayed / Cancelled:** Yes No N/A**Bridge No:** 34-0006**Component:** Tower Boom**Summary of Items Observed:**

**Pier 7 Tower Boom Component: Outrigger Beam West #2**

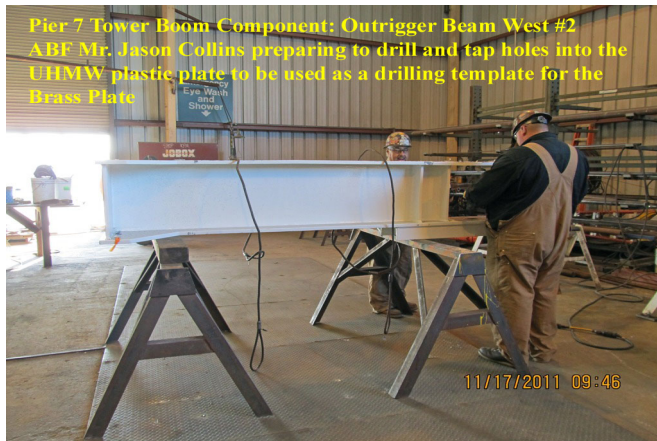
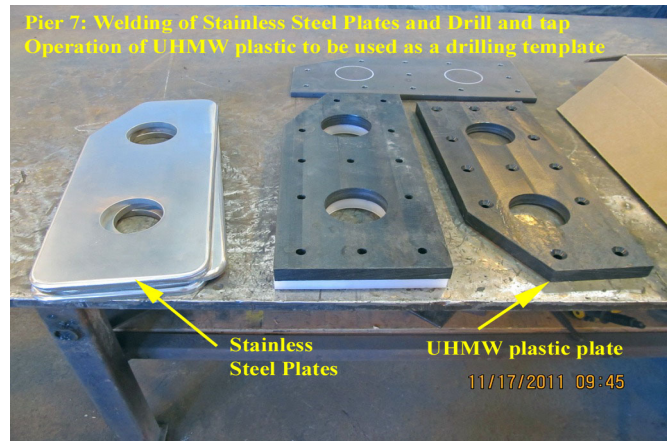
### Pier 7 Tower Boom Component: Outrigger Beam West #2

This QA Inspector observed ABF personnel Mr. Jason Collins performing the drill and tap operation - 9.5 diameter ASTM A276 Type 316 countersunk bolts for installation of the UHMW plastic plate to be used as a drilling template for the brass plate on the Tower Boom Component Outrigger Beam West #2. The drill and tap operation was completed on the UHMW plate template and installed until the brass plate arrived at the end of January, 2012.
